Manhole Inspection Summary

Manhole # S35M__021MH

Insp Date: **5/5/09 10:37 AM**

Location Address: **LIGHT ST - IN INTERSECTION**

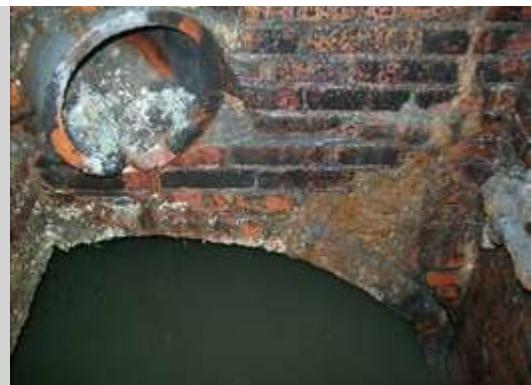
6 O'Clock Inflow

66 in. Circular Gravity Sewer
Pipe In @ 6 O'Clock

Pipe Height: **66** (in.) Rod and Bar (Angled)

Infiltration: **None** Pipe Seal Cond: **Sound**
